TECHNICAL REPORT REMR CO-3

CASE HISTORIES OF CORPS BREAKWATER
AND JETTY STRUCTURES

Report 1
SOUTH PACIFIC DIVISION

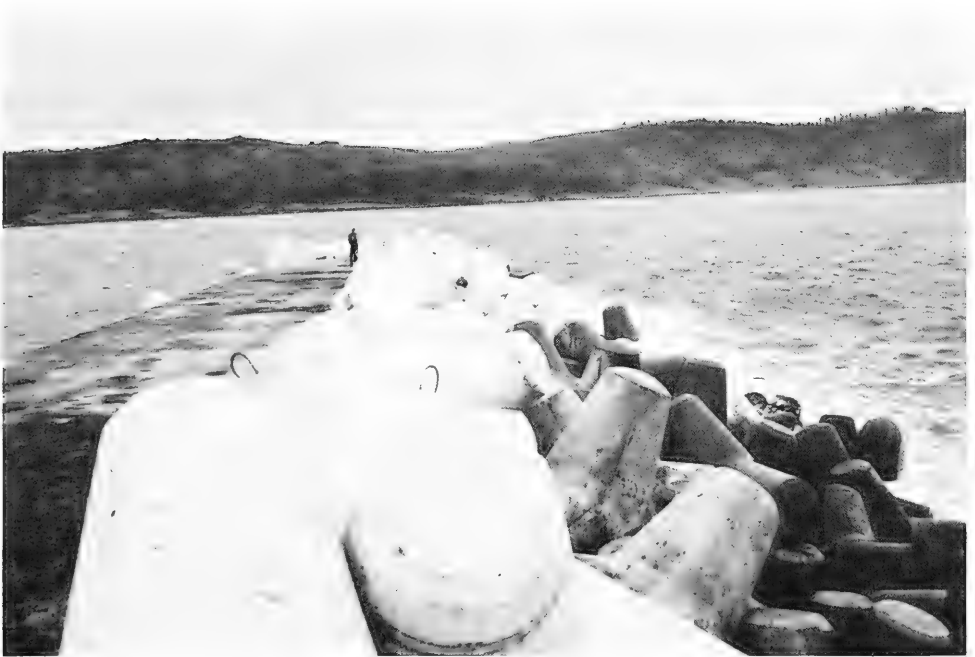
Figure 5. View of tetrapods at head of Crescent City Harbor outer breakwater

Date(s)	Construction and Rehabilitation History
1957	The 1,000-ft-long outer breakwater extension, as authorized in 1952, was completed. Twelve-ton stone protection was used from sta 36+70 to 41+20. From sta 41+20 to 46+70, 25-ton unreinforced tetrapods (1,836 units) were placed on the seaward slope (Figure 5). Model tests were conducted (US Army Engineer Waterways Experiment Station (WES), Hydraulics Laboratory (HL) 1953, 1956).
1957- 1964	Damages occurred to a portion (sta 36+70 to 41+20) of the outer breakwater, and in 1964 were repaired using 12-ton stones and 140 25-ton tetrapods. The tetrapods were not model tested for their adequacy for placement in this area, and they were destroyed over a period of years.
1973	Repairs were made to the concrete cap of the outer breakwater between sta 35+40 and 37+00.
1974	Rehabilitation of the outer breakwater between sta 34+70 to 37+00 was completed. Two layers of 40-ton unreinforced dolosse (246 units) were placed on the seaward slope.

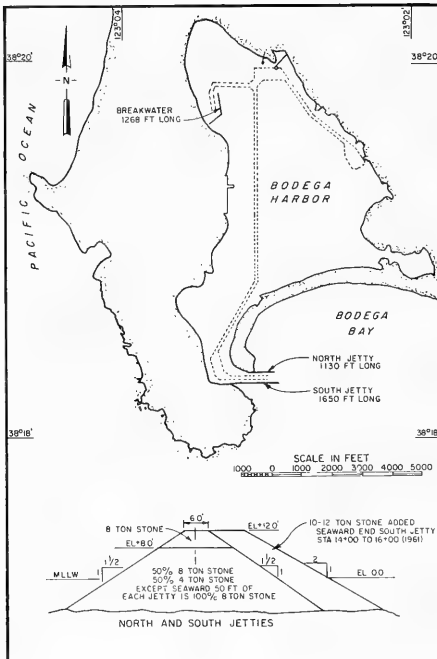
Figure 9. Bodega Harbor, California

Date(s)	Construction and Rehabilitation History
1943	The initial construction of the north and south jetties was completed at the site (Figure 9). The north and south jetties were rubble-mound structures with lengths of 1,130 and 1,650 ft, respectively, with crest els of +12 ft mllw and 1V:1.5H side slopes.
1961	Rehabilitation of the channels and south jetty was completed for a cost of \$399,800. Stone was added to the seaward side of the jetty between sta 14+00 and 16+00. The side slope of the structure over this 200-ft length was changed to 1V:2H.
1985	A 1,268-ft-long baffled-concrete pile breakwater was constructed by local interests in the northern portion of Bodega Harbor (Figure 9) to protect small craft moored there from damages resulting from wave action. The breakwater was approved for maintenance by the CE in November.
1986	The structures presently are in satisfactory condition.

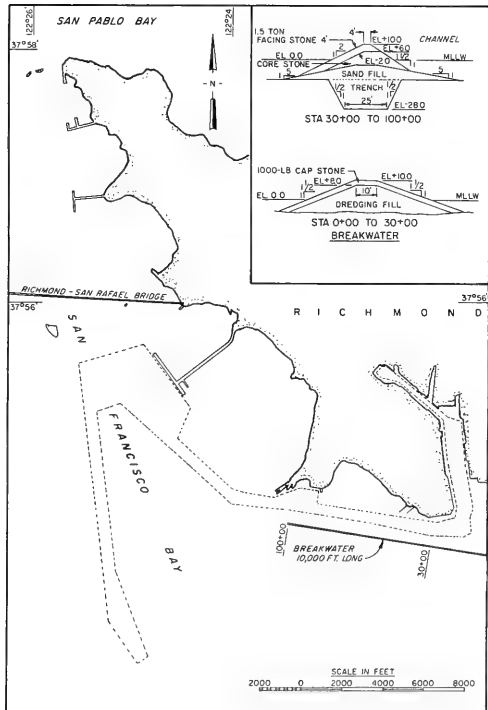
Figure 10. Richmond Harbor, San Francisco Bay, California

Date(s)	Construction and Rehabilitation History
1923-1931	Construction of a 10,000-ft-long breakwater (also referred to as a training wall) was completed (Figure 10) during this time frame. The seaward 3,000-ft-long portion of the breakwater had a 10-ft crest width and a 10-ft mllw crest el. Side slopes were 1V:1.5H. The remaining portion of the breakwater entailed a 10-ft mllw crest el and a 4-ft crest width. Side slopes were 1V:2H on the bay side and 1V:1.5H on the channel side.
1967	Rehabilitation of the breakwater was performed. The extent of the work is not known, however.
1985	The breakwater again underwent repairs and is considered to be in good condition.

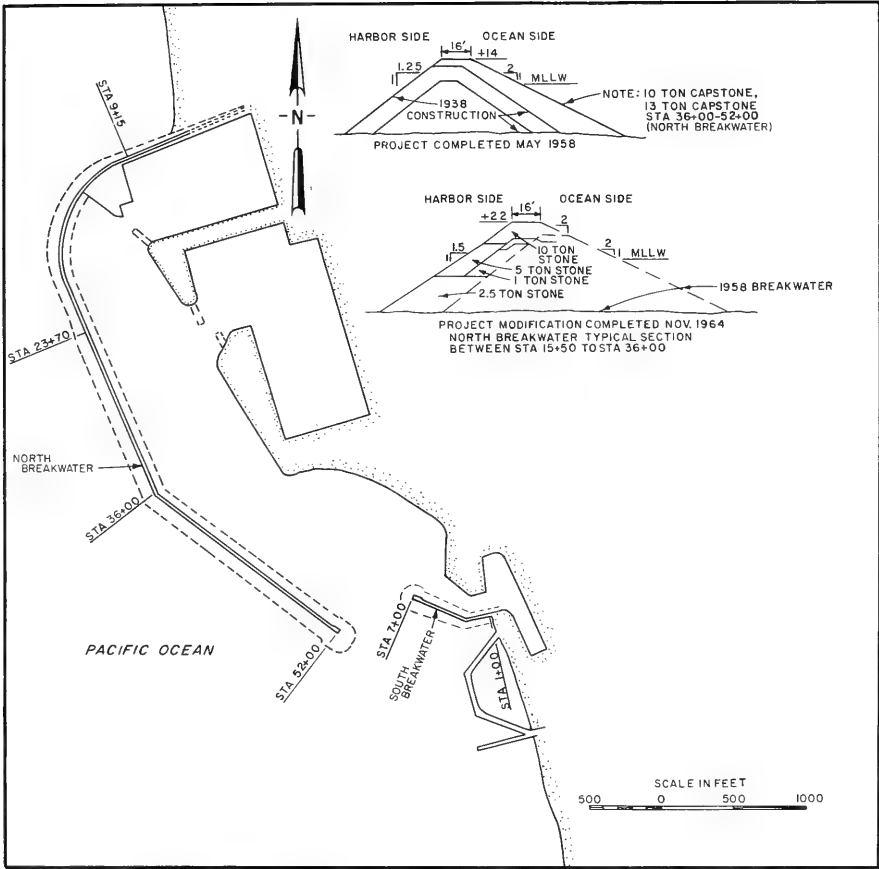
Figure 28. Redondo Beach King Harbor, California

<u>Date(s)</u>	<u>Construction and Rehabilitation History</u>
1938	Construction of a 4,285-ft-long permeable, rubble-mound breakwater (Figure 28) was completed.
1950	The breakwater became a Federal project, and improvements were authorized.
1958	Ten-ton capstones were placed on the ocean side of the breakwater on a 1V:2H slope, and the crest was raised to +14 ft mllw and increased to 16 ft in width. Thirteen-ton capstones were used on the breakwater between sta 36+00 and 52+00. A 600-ft-long south breakwater with a crest el of +14 ft was constructed. The structure has a 16-ft crest width, and side slopes were 1V:2H on the sea side and 1V:1.5H on the harbor side.
1960	Minor repairs to the north breakwater (from a storm in 1959) were completed.
1963	Storms demonstrated the inadequacy of the north breakwater for protecting small craft within the Harbor. While doing only minor damage to the breakwater, damage to small boats and Harbor facilities amounted to \$431,000.

1964	The north breakwater (between sta 15+50 and 36+00) was modified. The structure crest el was raised to +22 ft mllw at this location. Stones, ranging from 2.5 to 10 tons, were placed on the harbor side of the breakwater on a slope of 1V:1.5H (Figure 28).
1978- 1980	Storms of 1978 and 1980 resulted in damage to the north breakwater in nine areas with major voids occurring at sta 16+00 and 22+00.
1982	As a result of the damages in 1978 and 1980, the north breakwater was repaired at a cost of \$304,000.
1983	Storms resulted in significant damage at several locations along the north breakwater. The most significant was a breach 70 ft long, just south of the curved portion. Repair work was completed, and approximately 5,300 tons of new capstone and 1,700 tons of corestone were utilized. At seven additional locations, about 4,000 tons of capstone were replaced. The repair work cost approximately \$400,000.

1986	The breakwaters presently are in satisfactory condition.

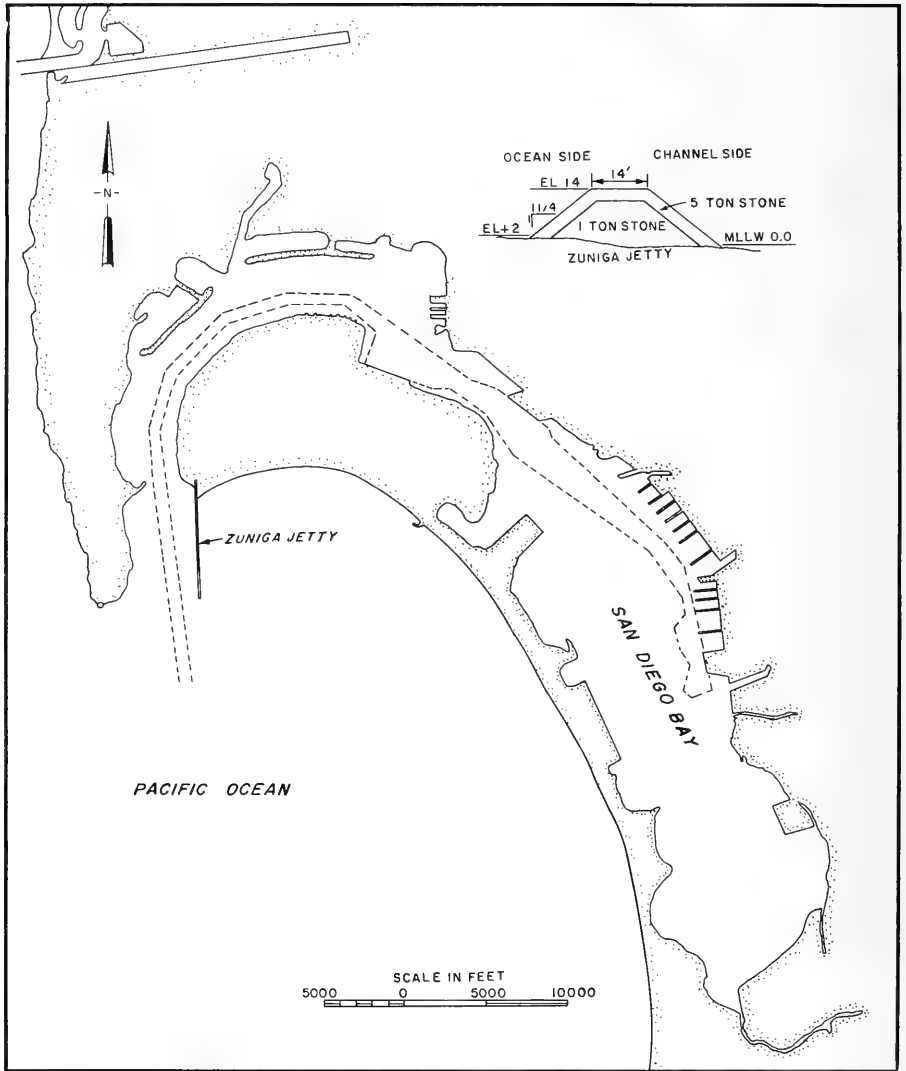
Figure 35. San Diego Harbor, California

<u>Date(s)</u>	<u>Construction and Rehabilitation History</u>
1894- 1902	Construction of a 7,500-ft-long rubble-mound jetty (Zuniga Jetty) was completed (Figure 35) during this time frame. The design height of the jetty was +14 ft mllw with a 14-ft-wide crest. Side slopes were 1V:1.25H. It is indicated, however, that the jetty was not constructed to the full design height.
1942	Rehabilitation work was performed by the US Navy from the shoreward end to a point about 1,400 ft seaward.
1943- 1969	Settlement and flattening of the slopes occurred, particularly in the outermost third of the jetty. As a result, parts of the jetty were awash or submerged at most tide stages, creating hazards to navigation.
1970	Maintenance repair of the jetty was accomplished for a cost of approximately \$127,000. This work consisted of the construction of platforms on the jetty for navigation lights which were installed by the US Coast Guard to alleviate hazards to navigation.

1984	Maintenance repair of the jetty was completed, the extent of which is unknown.
1986	Even though the jetty was not constructed to full design height, it functions satisfactorily as a training wall which concentrates tidal flows and keeps the entrance channel scoured to project depth.
